Forensic Engineering and Visualization

4215.Goodnight
June 22, 2021

Report

Case Name: Waterdown v. Mesilla Valley
Date of Incident: May 13, 2018

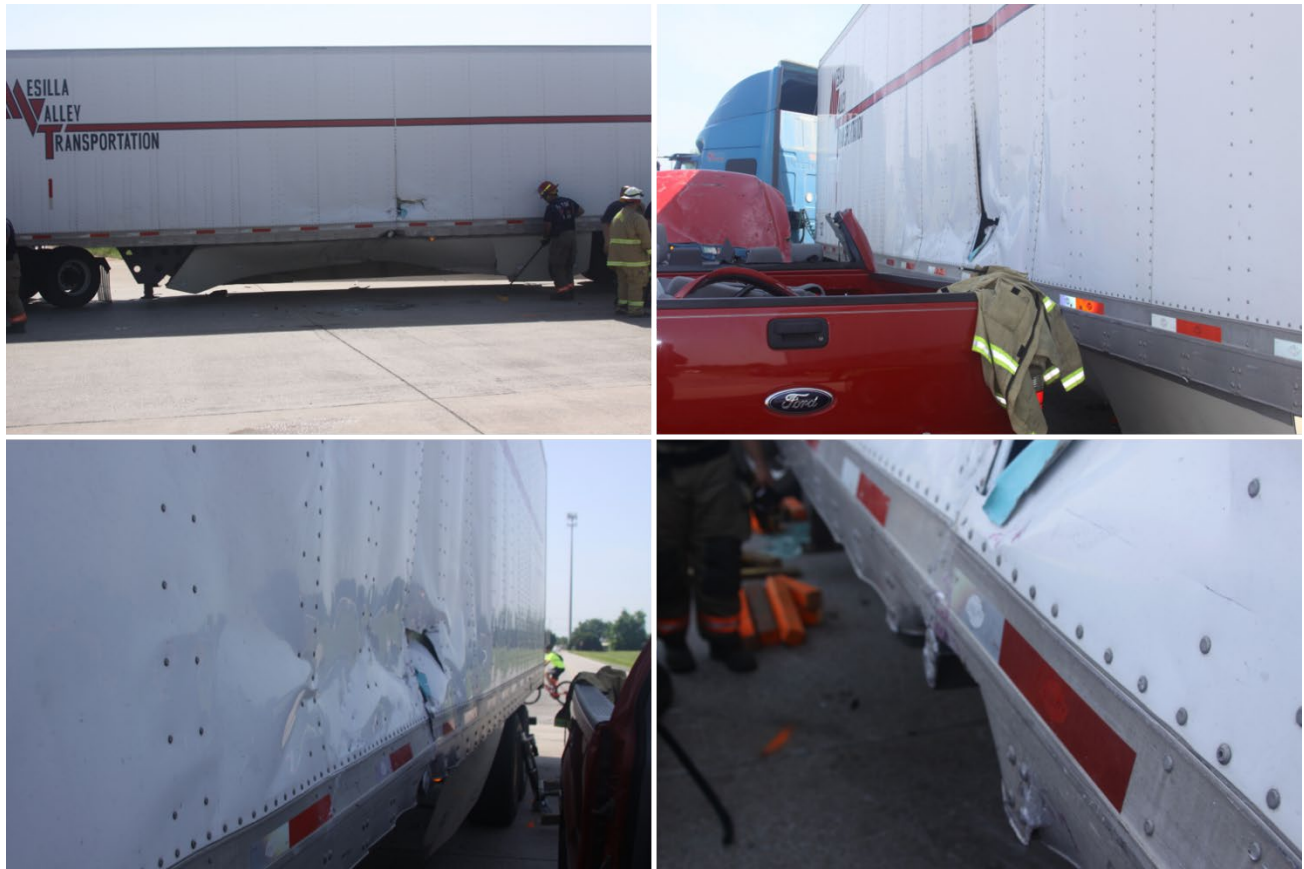
Figure 7 – Subject Utility Semi-Trailer Damages

Utility Semi-Trailer: Vehicle 1 in this incident, the 2015 International ProStar, was pulling a Utility semi-trailer. The Utility trailer is a box van trailer of 53 feet total length with tandem axles. The center of the trailer had visible contact damage, including dents and tears to the driver's side trailer wall. The provided police photographs in Figure 7 show the damages to the subject Utility semi-trailer.

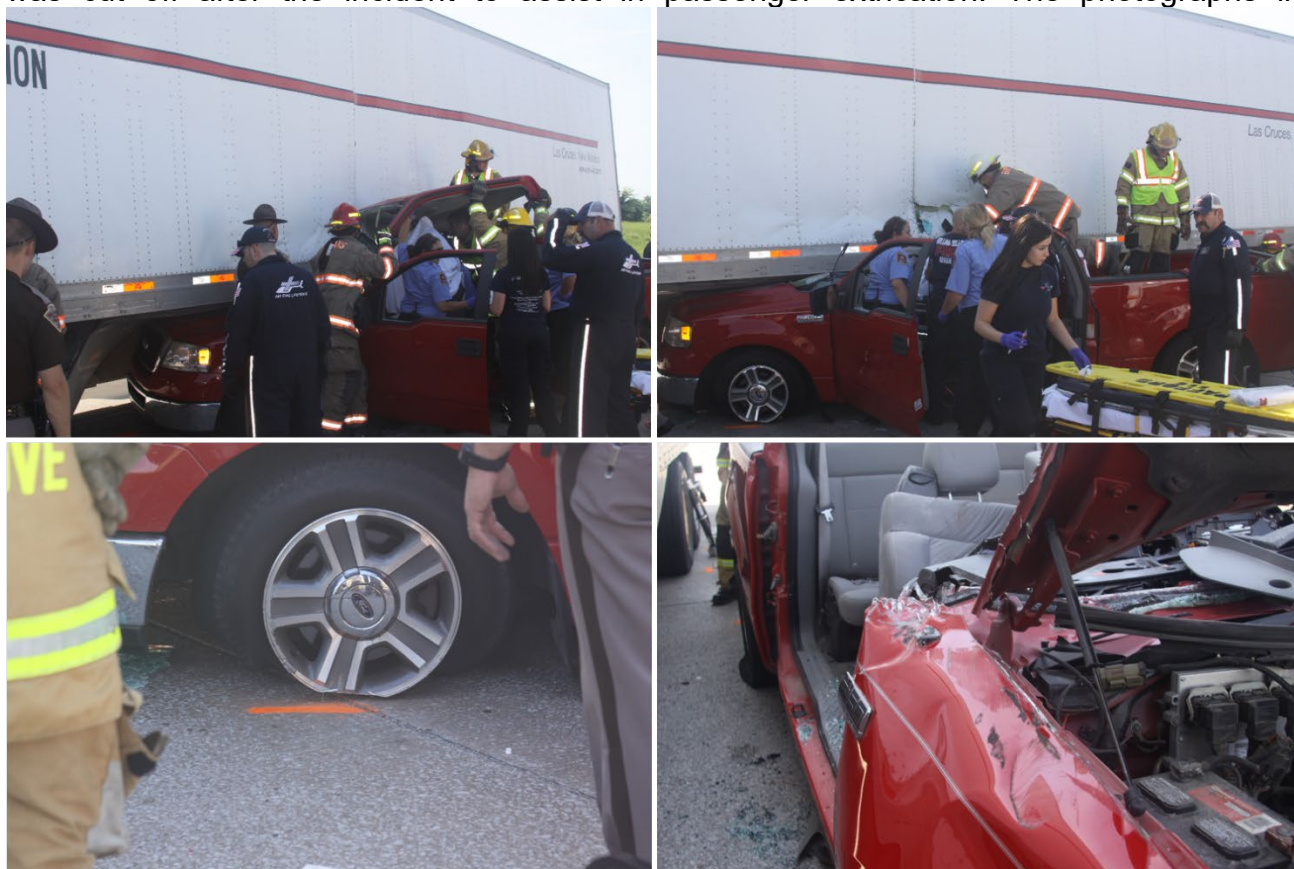
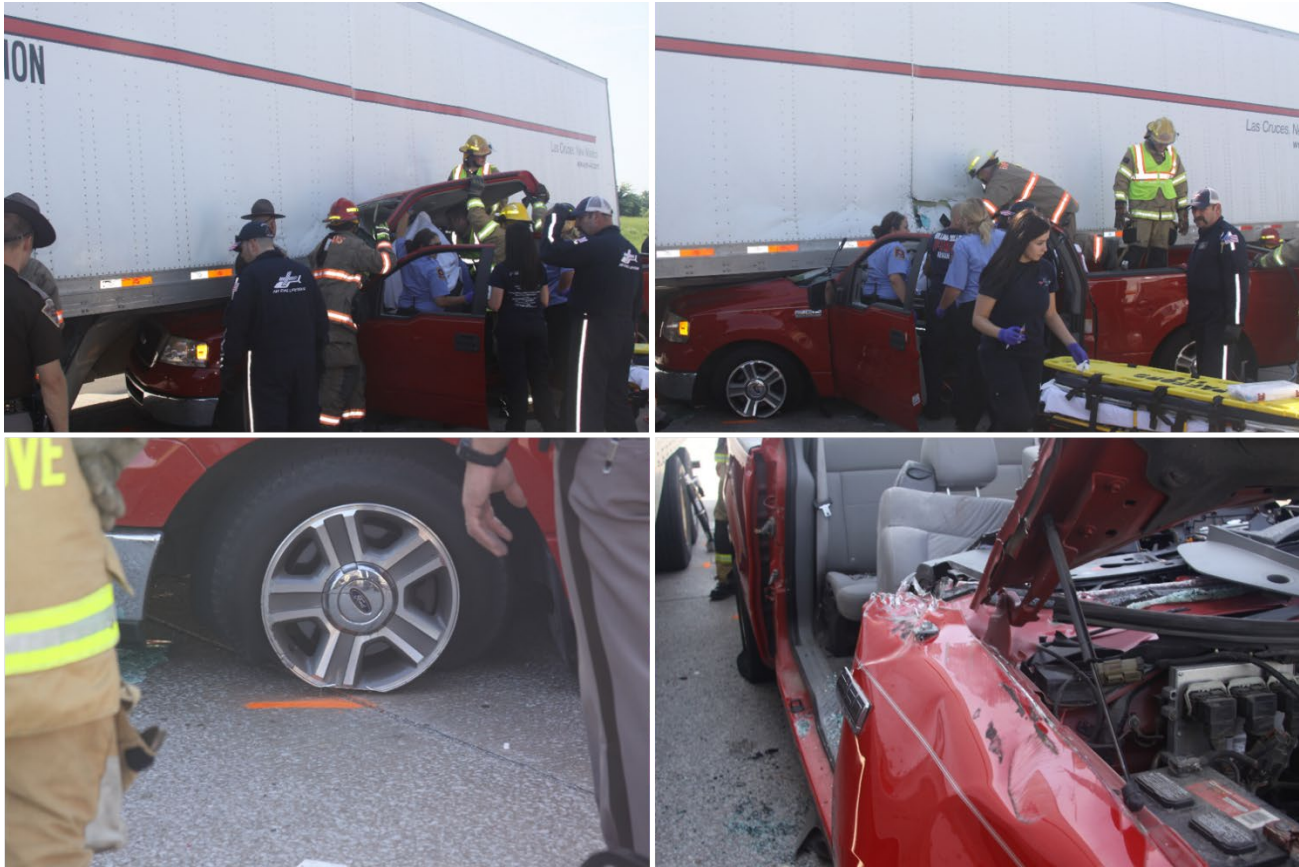
Figure 8 – Subject 2007 Ford F-150 Damages

2007 Ford F-150: Vehicle 2 in this incident, as designated by the Oklahoma police report, is a 2007 Ford F-150, driven by Matthew Waterdown. The 2007 Ford, bearing the VIN - 1FTPX12V57FA39344, is a passenger vehicle with a 5.4L V8 engine. The Ford had contact damage to the front, including the hood, windshield, roof, and other body panels. The roof

was cut off after the incident to assist in passenger extrication. The photographs in

Figure 8 show damages to the Ford from provided police photographs.

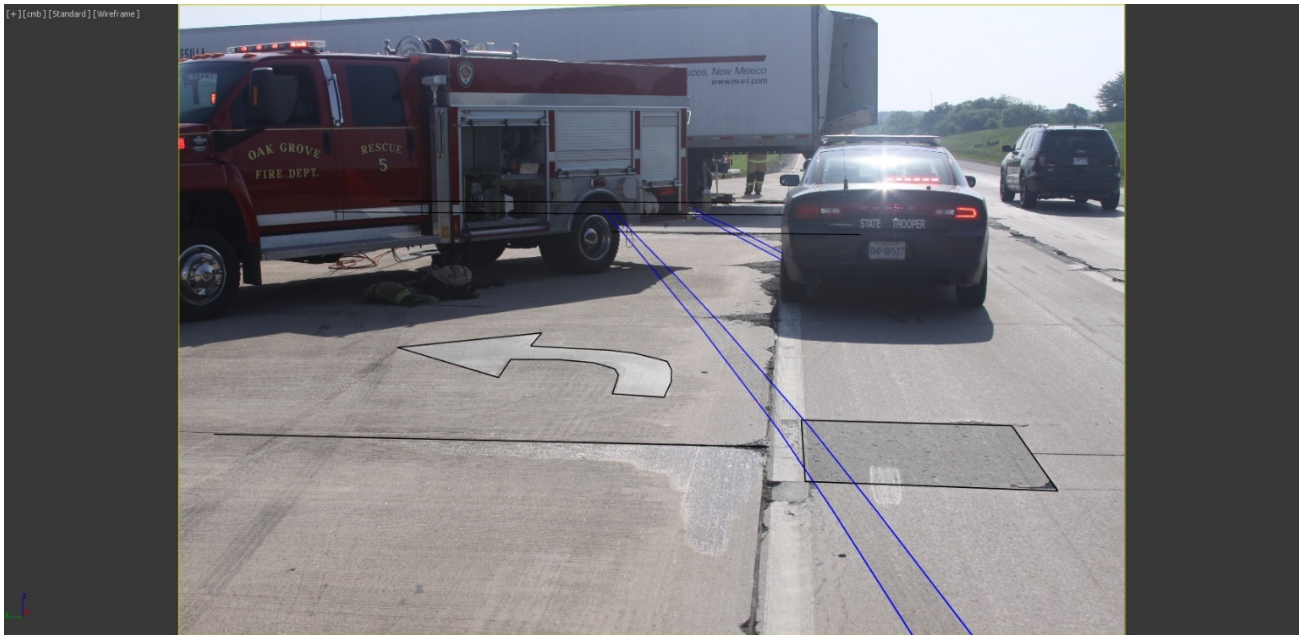
Figure 11 - Tire Marks in Impact Area

Physical Evidence: Inspection of the provided police photographs show a set of tire marks leading into the side of the tractor trailer. The tire marks shown in the photographs are consistent with the police report stating the Ford swerved to the left in an attempt to avoid the collision. The tire marks can be seen in Figure 11, outlined in a camera-matched provided police photograph.

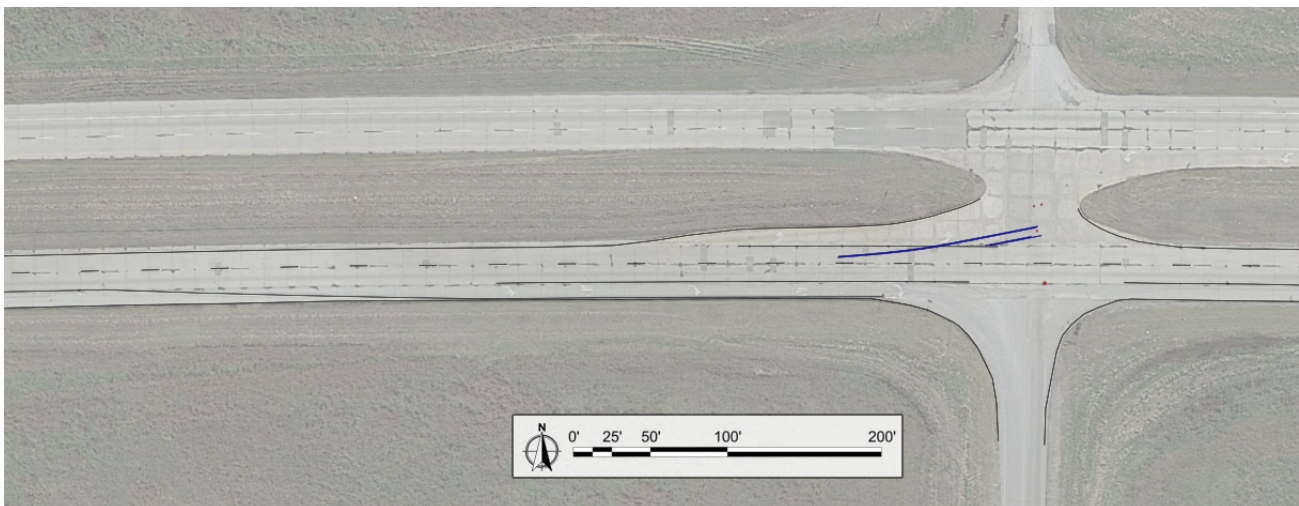
Figure 12 - Kineticorp Scene Diagram with Camera-Matched Physical Evidence

As seen in Figure 12, the tire marks deposited by the left (driver's) side of the Ford's begin within the right travel lane and then angle towards the center of the intersection. A tire mark from the right (passenger's) side of the Ford can be seen closer to the point of impact.

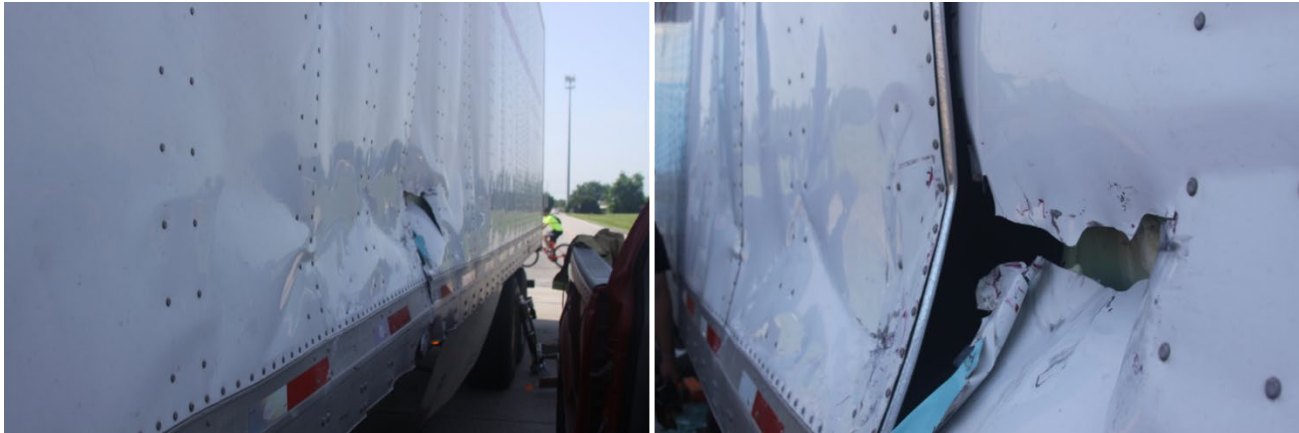
Figure 14 - Subject Utility Trailer Damage

Impact Configuration: To determine the impact configuration between the Ford and the Utility trailer, an analysis was performed using the damages to the vehicles. The Utility trailer has damage on the left (driver) side that correspond to specific damage locations on the Ford. The most severe damage was located on the left side near the middle of the Utility trailer, as seen in police photographs in Figure 14.

The left (driver) trailer wall shows multiple dents and a tear in the trailer skin resulting from the impact with the Ford. In addition, the trailer side skirt was also pushed inwards during the collision.

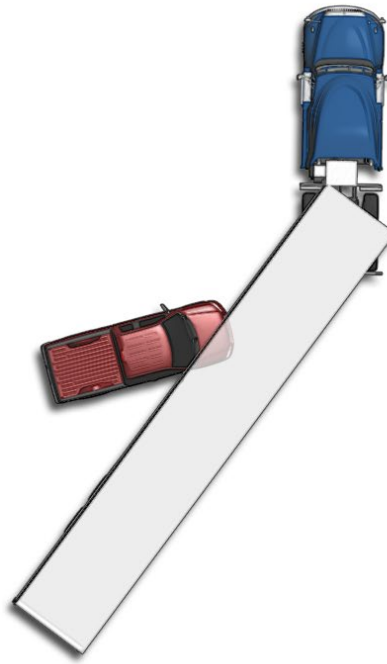
Figure 15 – Impact Configuration

Provided photographs along with physical evidence and damage locations on the subject Utility trailer and Ford were used to locate the International tractor, Utility trailer, and Ford at the time of impact relative to the roadway. The impact configuration was positioned into the 3D scene diagram and oriented based on the Ford's initial tire marks and the locations of both vehicles in provided photographs and videos. Figure 15 shows the impact configuration in the scene diagram.

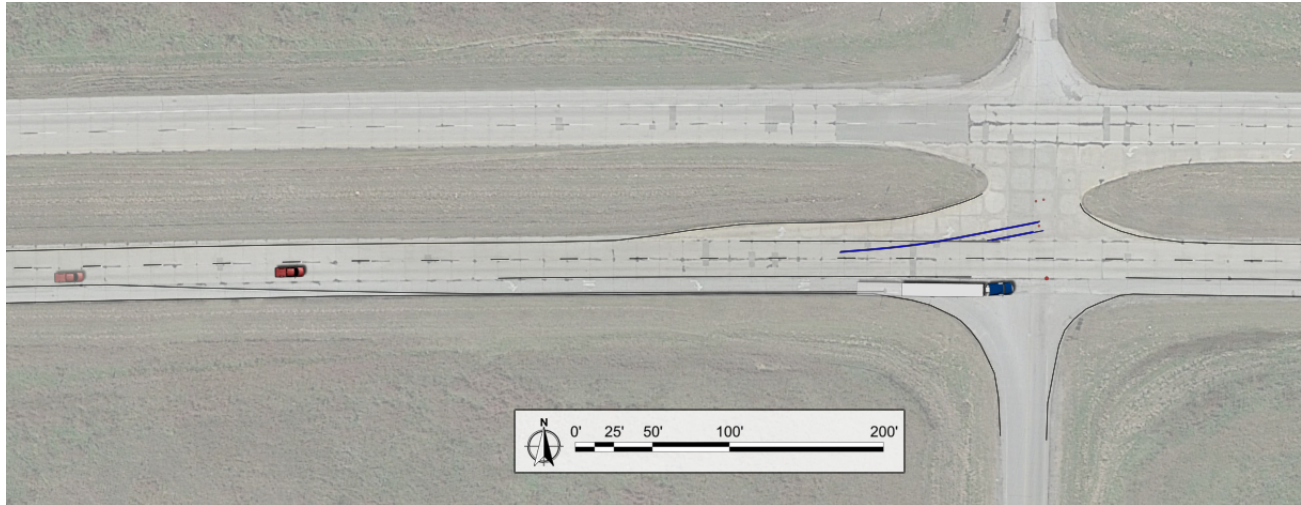
Figure 16 - International Starts to Turn Left (484 feet and 5.5 seconds before impact)

Time-Space Analysis: Time-space analysis was performed to determine the pre-impact positions and speeds of the Ford and International tractor-trailer. The analysis shows at the time the International began to turn to the left, the Ford was approximately 484 feet from the point of impact. In Figure 16, each position of the Ford corresponds the position of the International Tractor and Utility trailer. The darker colored vehicles in Figure 16 shows the positions of the vehicles when the International began to make the left turn maneuver.

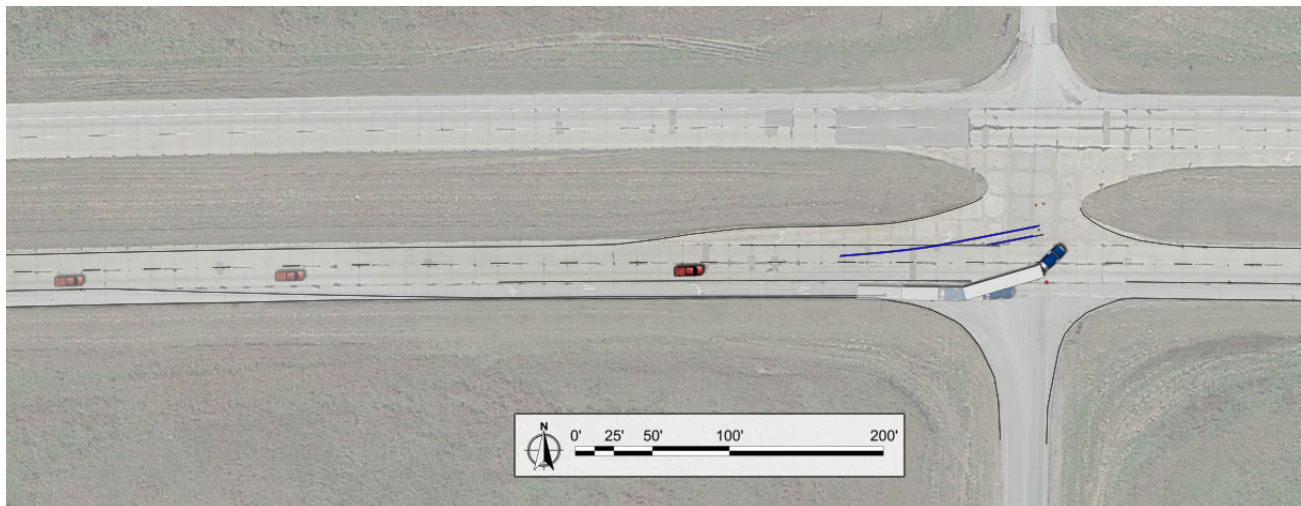
Figure 17 - Ford Start of Swerve (Ford 225 ft and 2.8 seconds before impact)

The analysis also showed the Ford started to swerve to the left from the right lane approximately 2.7 seconds after the tractor began to turn left. When the Mr. Waterdown began to swerve left, the Ford was approximately 225 feet from the point of impact. Figure 17 shows the position of the Ford and International/Utility trailer at the beginning of the swerve maneuver.

The time elapsed from the beginning of the turn of the International to the steering response by Mr. Waterdown was approximately 2.7 seconds. Perception-reaction time research performed by Jeff Muttart shows that the average response time is approximately 1.6 seconds, with 85% of people reacting within 2.2 seconds⁷. The reaction time of Mr. Waterdown of 2.7 seconds was approximately 0.5 seconds slower than the 85th percentile response. Therefore, the Mr. Waterdown had a longer perception-reaction time than what would be expected 85% of drivers.

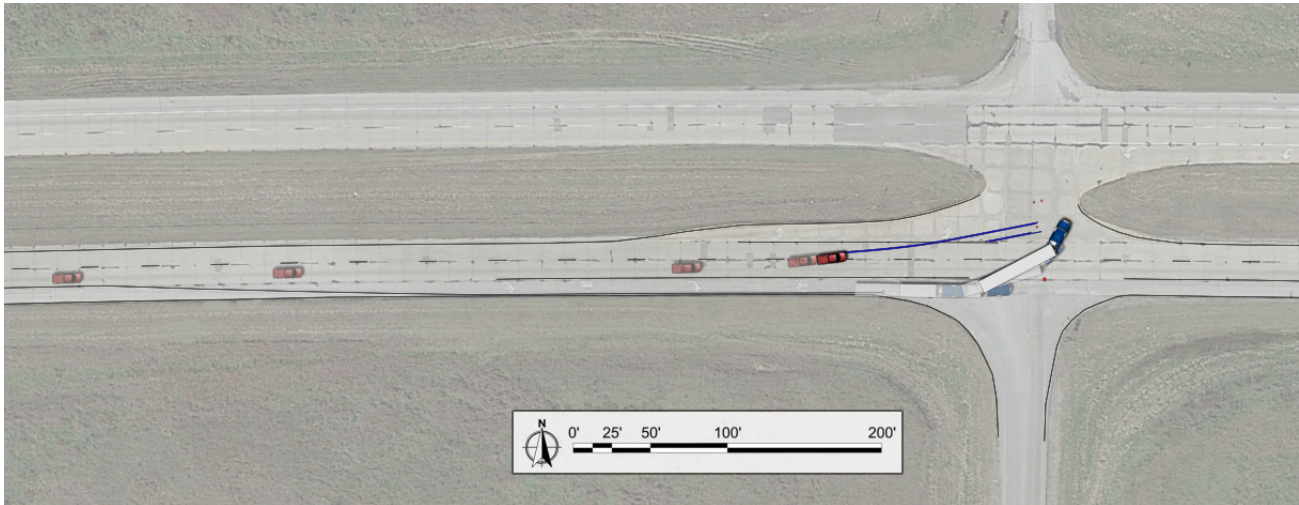
Figure 18 – Location of Ford 2 Seconds (150 ft) Prior to Impact

the Ford was approximately 1.8 seconds and 131 feet from the point of impact. Figure 18 shows the location of the Ford at the beginning of the tire marks and the location of the International tractor. Furthermore, the 1.8 seconds is also consistent with the tire screeching sounds recorded by the Drive Cam video.
